Technical Service Handbook

4545, KL, KM7: Irregular operation of the electric parking brake with the Autohold or EPB activated

Transaction No.: 2063188/4

Release date 16-Feb-2022

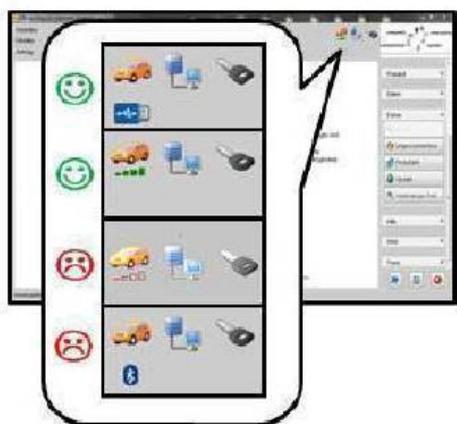
If the WiFi signal is not strong enough a note is displayed (see Figure 1), and the USB cable must be used.

Figure 1: Example of the information icons when there is sufficient or insufficient signal via WiFi / Bluetooth.
