Technical Service Handbook

9666, KM, Customer complaint: Kessy access and ignition authorisation system: keyless opening impossible

Transaction No.: 2061979/2

Release date 01-Feb-2022

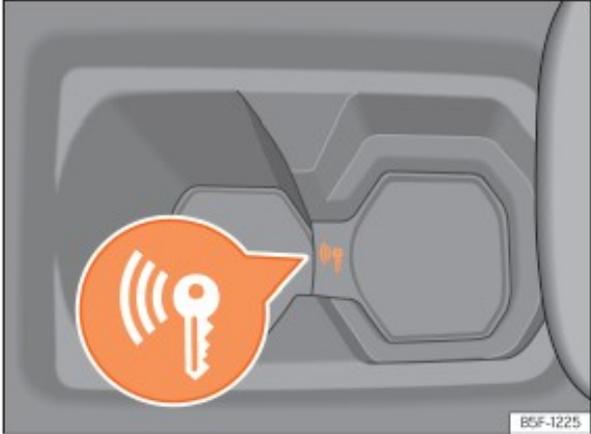
Take into account that in vehicles equipped with "KESY" which do not have an ignition lock, the ignition key must be inserted in its housing according to the following photo:

Connect the diagnostics equipment to the vehicle and carry out an update of the access and ignition authorisation control unit (diagnostic address 00B7) using the guided function at the following path:

- Software version management -> Adapting software -> 1. Software update via measure code

Use test code "**34DF**"

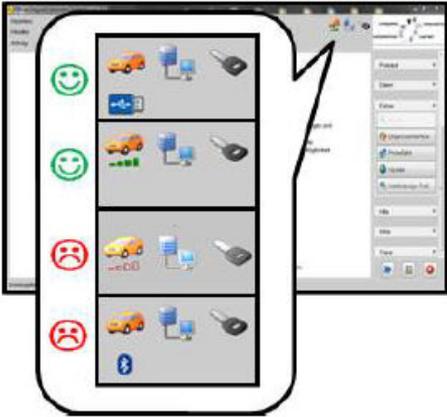
- The flash update can be done both with a USB cable and via WiFi if the signal is strong enough.
- If the WiFi signal is not strong enough a note is displayed and the USB cable must be used.
- The use of Bluetooth is still currently not allowed.
- Before connecting the USB cable, remove the diagnostics unit radio communication terminal!
- If the USB cable is connected while the radio communication terminal is attached, the communication will be established via Bluetooth.

- Connect the online diagnostics equipment to the vehicle diagnosis connection and to the workshop server.
