Technical Service Handbook

Technical product information

Update of software packages (baselines)

Transaction No.: 2066692/1

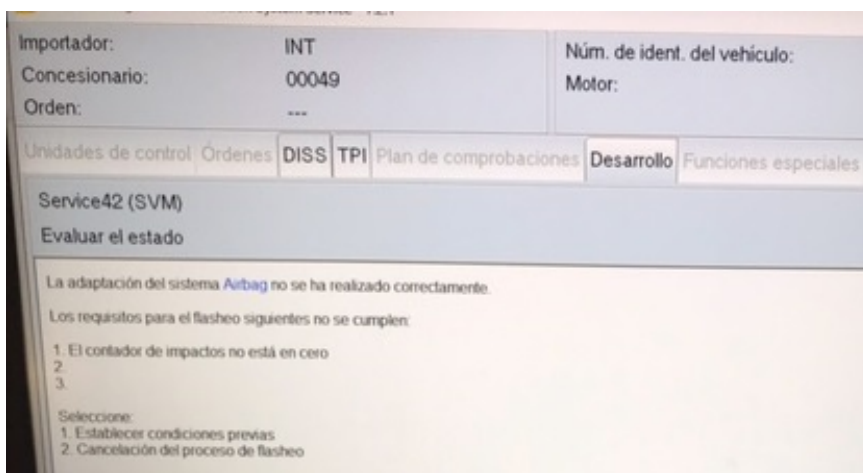
Figure 8: Example of the diagnostics equipment screen.

Indication 2: The Airbag control module 0015 does not allow the software to be updated.

In certain cases, the Airbag control module with SW 0036 detects that the impact counter is not at zero and does not allow it to be updated.

- To resolve this error, the Airbag control module 0015 must be replaced.
