Current Flow Diagrams

León 2016

No. 125 / 1

Reversing camera (Rear Assist)

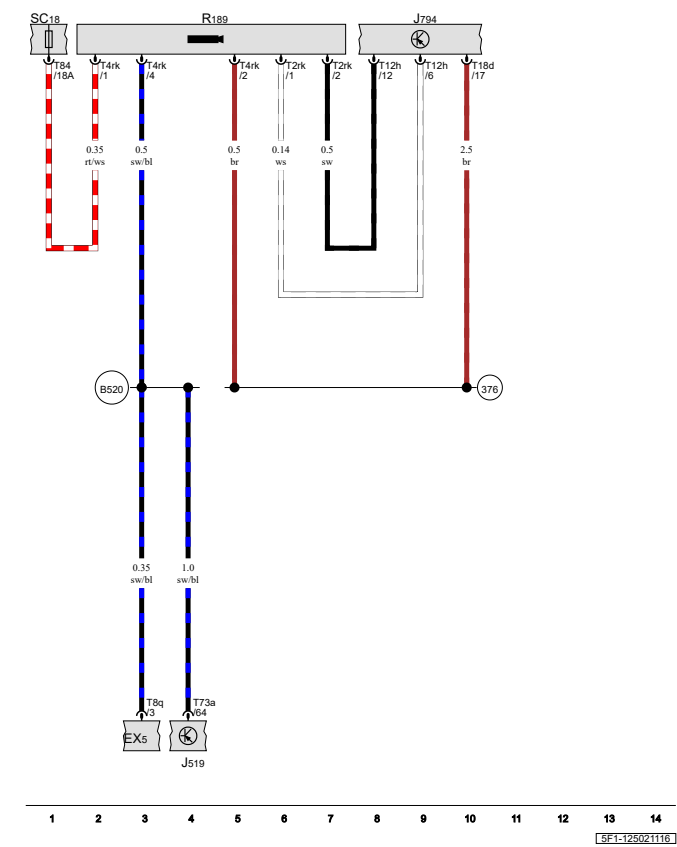
Onboard supply control unit, Control unit 1 for information electronics, Reversing camera

- EX5 -Interior mirror
- J519 -Onboard supply control unit
- J794 -Control unit 1 for information electronics
- R189 -Reversing camera
- SC18 -Fuse 18 on fuse holder C
- T2rk -2-pin connector
- T4rk -4-pin connector
- T8q -8-pin connector
- T12h -12-pin connector
- T18d -18-pin connector
- T73a -73-pin connector
- T84 -84-pin connector
- 376 -Earth connection 11, in main wiring harness
- B520 -Connection (RL), in main wiring harness
